State of California -- The Resources Agency
DEPARTMENT OF PARKS AND RECREATION
PRIMARY RECORD

Page 1 of 2 *Resource Name or #: (Assigned by recorder) South Bay Yacht Club

Neighborhood of Alviso Historic Context and Survey

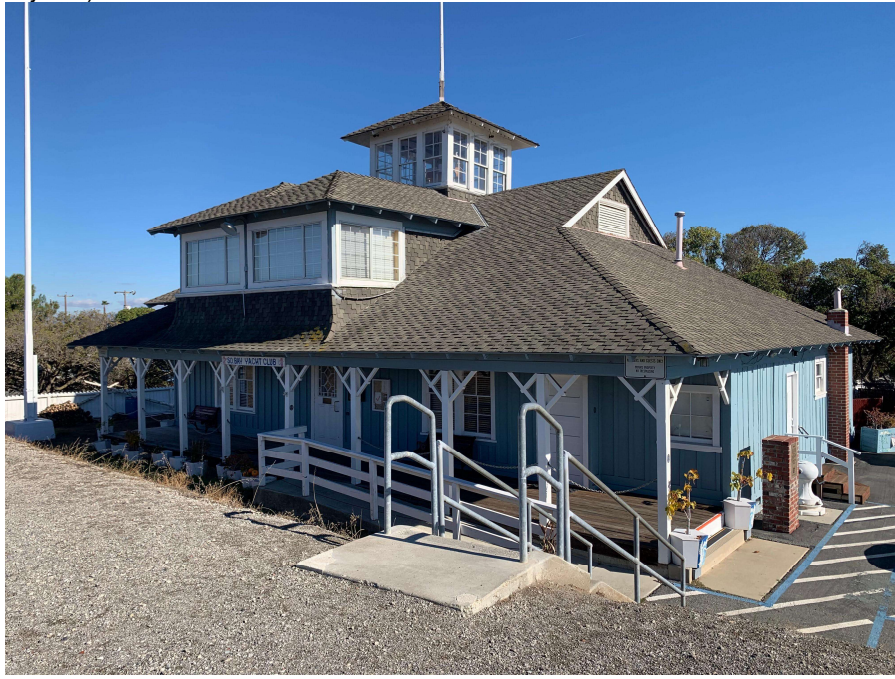
P5a. Photograph or Drawing (Photograph required for buildings, structures, and objects.)

The building at 1491 Hope Street is two-story, irregular plan wood frame building located immediately east of the crest of the Guadalupe River levee. The building is topped by a dramatic hip roof with a front-facing gabled dormer with flared sides, and a central cupola. The roof and dormer walls are clad in asphalt shingles. The building is clad with board and batten siding. A deeply set front porch is supported by square posts with corner brackets. The west (primary) façade faces the levee and the Guadalupe River beyond. Pairs of double-hung, four-over-four windows flank the main entrance. A secondary entrance is located south (right) of the windows and a two-by-two fixed window is located at the far southern edge of the façade. Most other windows are modern, tripartite vinyl sliding windows with simulated divided lites. The cupola is glazed on all four sides by groups of three four-over-four single hung wood windows. Rafter ends are exposed throughout. A simple chain is strung across the front porch to separate the wood porch deck from the surrounding landscape. See Continuation Sheet.

P5b. Description of Photo: (view, date, accession #) View from the top of the Guadalupe River Levee, looking northeast, November 2022
