PHASE I ENVIRONMENTAL SITE ASSESSMENT

3090 S Bascom Avenue
San Jose, California

AEC Project No. 19-286SD
June 9, 2019

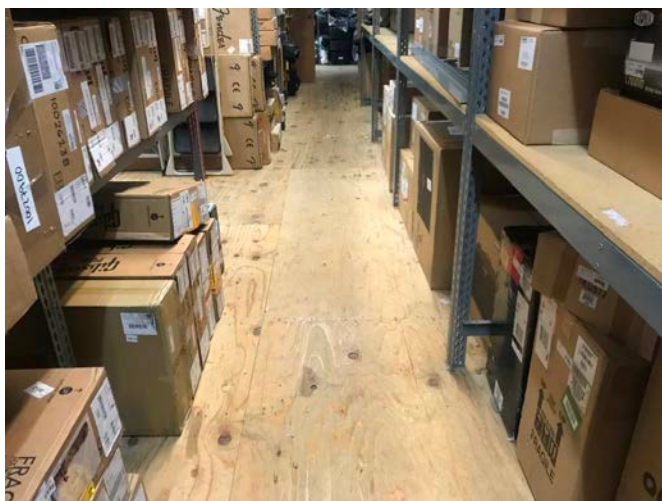
5. View of storage area.

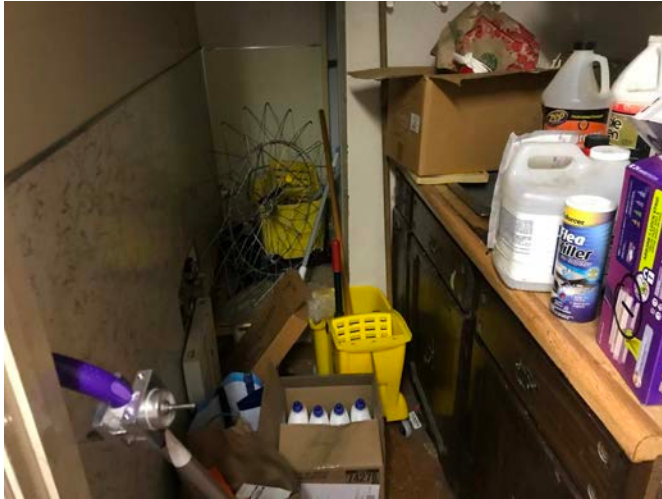
Retail-sized containers of cleaning products were observed at the Site. The containers appeared to be in good condition with no evidence of damage, leaks, or staining on or around them. An elevator is also located in the Site building. The elevator appears to be in good condition with no evidence of damage, leaks, or staining in the elevator equipment room.

7. View of cleaning supplies.

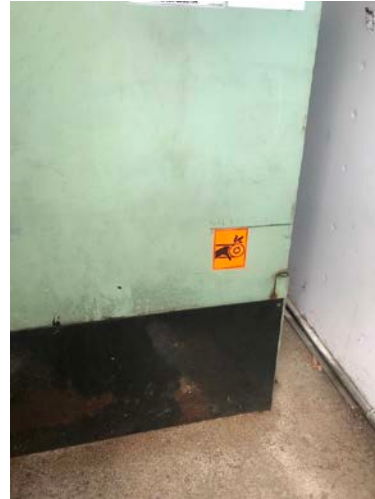
8. View of an elevator motor.

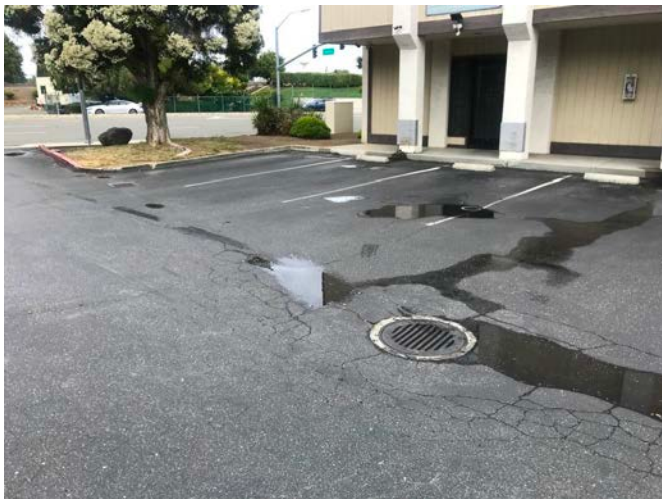
Water ponding from recent rainfall was observed in the central portion of the Site. No sheens or other suspect conditions were noted.

Area drains were noted in the parking area at the Site. No suspect environmental conditions were observed near the area drains.

9. View of an area drain and pooled water.

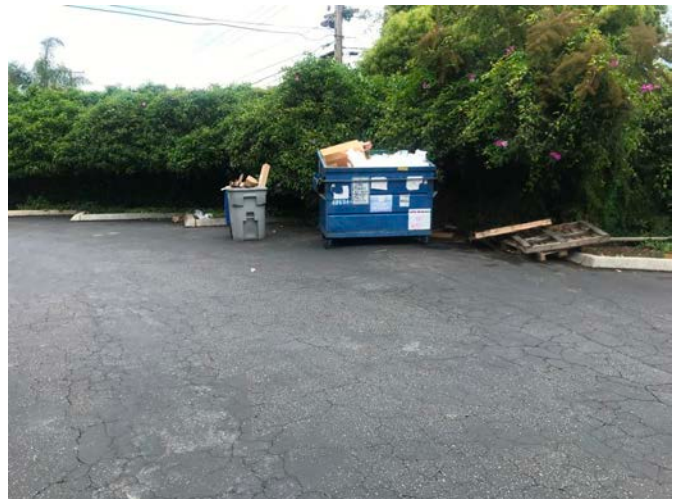
A trash dumpster was observed at the Site. No staining was observed in the vicinity of the dumpsters and no evidence of unauthorized dumping was observed on Site.

10. View of the dumpster.
