# ARBORIST REPORT

Revised: July 31, 2017  
4849.00

PROJECT  
Stevens Creek Executive Park

PREPARED BY  
HMH  
1570 Oakland Road  
San Jose, CA 95131  
Jake Minnick  
ISA Certified Arborist #WE-11830A

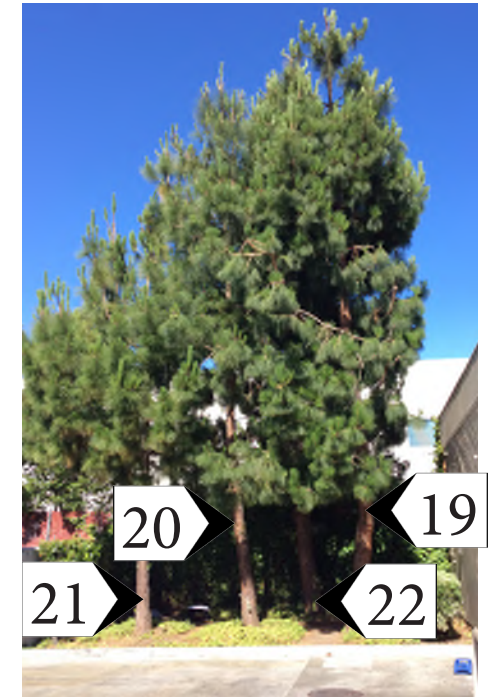
Another root girdling example.

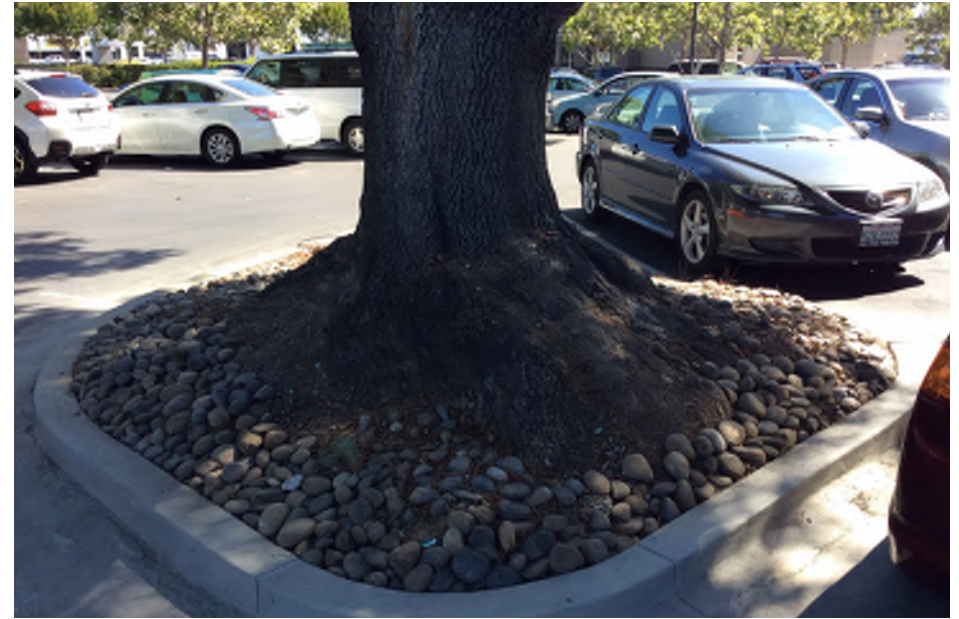
Recently repoured curb may have impacted root zone.

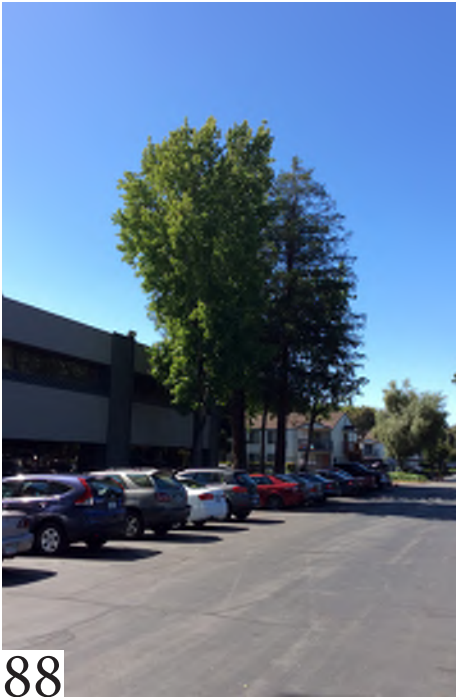
Typical structural deficiencies in several of the ashes.

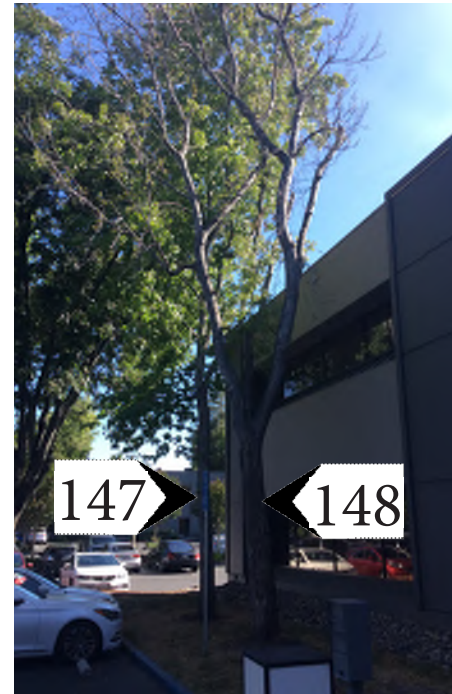
Typical damage from ash trees planted in confined finger islands and parking lot buffer strips.
